EPOXY RESINS IN MARINE COATINGS

ASSESSMENT OF POTENTIAL BPA EMISSIONS

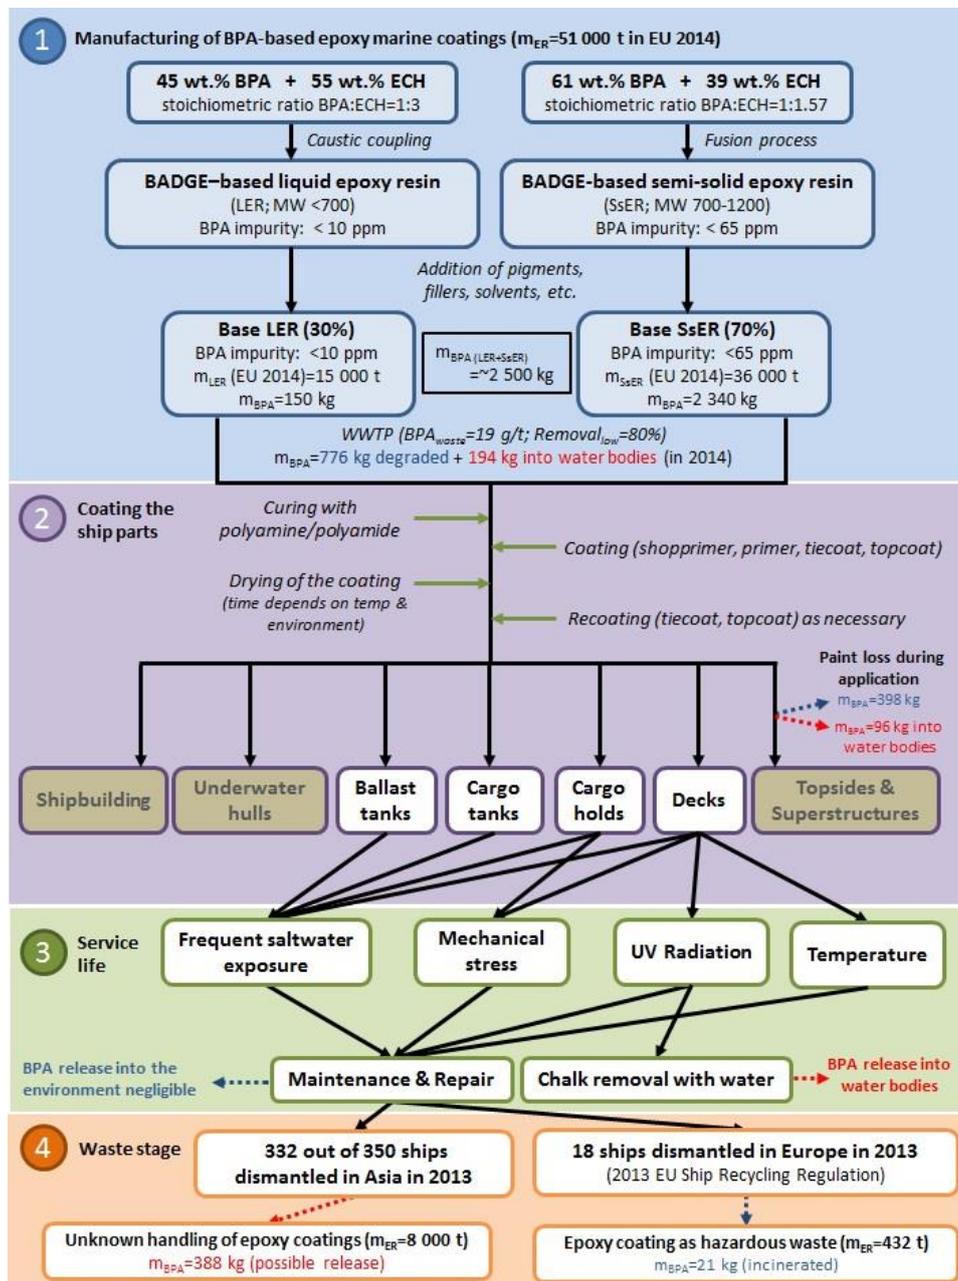
ANNEX: Life cycle stages and related BPA release for epoxy marine coatings

Marine coatings					
Annual epoxy usage mass (2014)	Annual BPA releases into environment				
	Production	Application	Service life	Waste	Total
51,000 t	max 194 kg	max 96 kg	not determinable	not determinable	> 290 kg

An estimated maximum amount of 290 kg of BPA could be released annually from marine coatings in Europe. Most potential release of BPA would happen during production of the resin (max. 194 kg, released into water bodies) and during coating (maximum 96 kg). Although release during service life could not be quantified, the most likely release may happen due to UV degradation of epoxy in topcoats. The waste stage presents major uncertainties due to dismantling of ships outside of Europe and the current EU regulatory framework.
