EPOXY RESINS IN WATER PIPES

ASSESSMENT OF POTENTIAL BPA EMISSIONS

The research on the potential emissions of Bisphenol A (BPA) from manufacturing, using and dismissing epoxy resins in water pipes was conducted by Beratungsgesellschaft für integrierte Problemlösungen (BIPRO) on behalf of the Epoxy Resin Committee (ERC). This is part of a series which analyses five key application sectors of epoxy resins in Europe. For more information, contact info@epoxy-europe.eu.

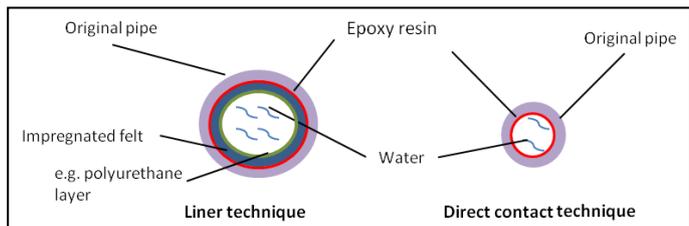
- **Liner technique:** A new tube made of felt (with a polyurethane layer inside the tube) is applied on the damaged part or section of the pipe. The felt tube is soaked with the epoxy resin and placed inside the damaged section of the pipe using air pressure. On site, the installation of the felt is done by inversion, thus placing the epoxy resin between the new and the old pipe. The epoxy coating acts as a binding agent, meaning it has no direct contact with water during service life.

With liner application, in principle, BPA losses are minimised by following the exact LER / hardener ratio suggested by the manufacturer in the instruction manual. Thus, when the installation is properly conducted, no BPA release in water can be expected because there is no direct contact of epoxy resin with water.
